# Dutch MH17 findings based on flimsy and partial evidence

By Richard Bardon

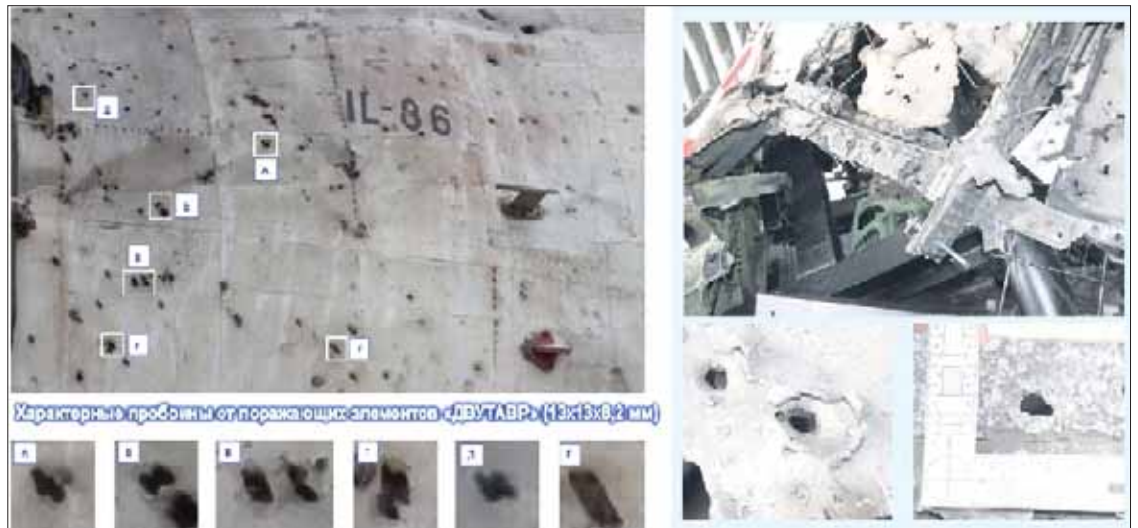
Left, the signature bowtie-shaped holes left by the 9N314M warhead's “double-T” shrapnel. MH17 (right) lacks similar damage. Photos: left, Almaz-Antey; right, Dutch Safety Board

The precise identification of the warhead hangs on the presence of three distinctive bowtie-shaped metal fragments recovered from the bodies of the captain and co-pilot, and a fourth, lodged in the aircraft's cockpit. According to the Dutch National Aerospace Laboratory (NLR), which analysed the damage to the aircraft's remains on behalf of the DSB, “Of the investigated warheads only the 9N314M contains the unique bowtie shaped fragments found in the wreckage. The damage observed on the wreckage in amount of damage, type of damage, boundary and impact angles of damage number and density of hits, size of penetrations and bowtie fragments found in the wreckage, is consistent with the damage caused by the 9N314M warhead used in the 9M38 and 9M38MI BUK surface-to-air missile.”<sup>2</sup> Therefore, the NLR did not even consider any of the other 20-odd types of SAMs operational in the Russian Federation and Ukraine that could theoretically have been available to either of the armed forces involved—the DPR forces and those of the Kiev regime. Instead, it produced computer models to ‘prove’ the version of events most convenient to the blame-Russia-for-everything school: MH17 had fallen foul of a modern version of the Buk, identical to those in service with the Russian military and launched from an area held by those whom the media like to name “Russian-backed separatists”. The Buk's manufacturer, Russian state armourer Almaz-Antey, has confirmed that the 9N314M is indeed the only warhead containing the bowtie-shaped

projectiles—which they call “double-T strike elements”—and demonstrated that, by virtue of that very fact, the scenario portrayed by the DSB was physically impossible.

The recovery of the tell-tale shrapnel having been announced in the DSB's 1 June preliminary report, Almaz-Antey engineers conducted and meticulously recorded a physical experiment to test the theory. Upon detonation of a 9N314M warhead beside a set of aluminium panels simulating the outer skin of an airliner, they found that the distinctive bowtie-shaped projectiles left equally distinctive bowtie-shaped holes, and lots of them. Of the 7,800 elements in each warhead, about 2,600 (one third) were of the double-T type. MH17 displays no such damage. Thus, “it became absolutely evident that if the Malaysian Boeing was downed by a BUK missile, it was done with an old Buk model which does not have double-T iron strike elements”, Almaz-Antey CEO Yan Novikov told a Moscow press conference in late July<sup>3</sup>. All data from the experiment were forwarded to the DSB for consideration, but were ignored.
